UNITED STATES DEPARTMENT OF AGRICULTURE
U.S. SOIL CONSERVATION SERVICE
WASHINGTON, D. C.
H. H. BENNETT, CHIEF
W. C. LOWDERMILK, ASSOCIATE CHIEF

ADVANCE REPORT
on the
SEDIMENTATION SURVEY OF BAYVIEW RESERVOIR
BIRMINGHAM, ALABAMA.

November 30, 1935 - January 25, 1936

Division of Research
Hydrodynamic Studies
SCS-SS-11
March, 1937

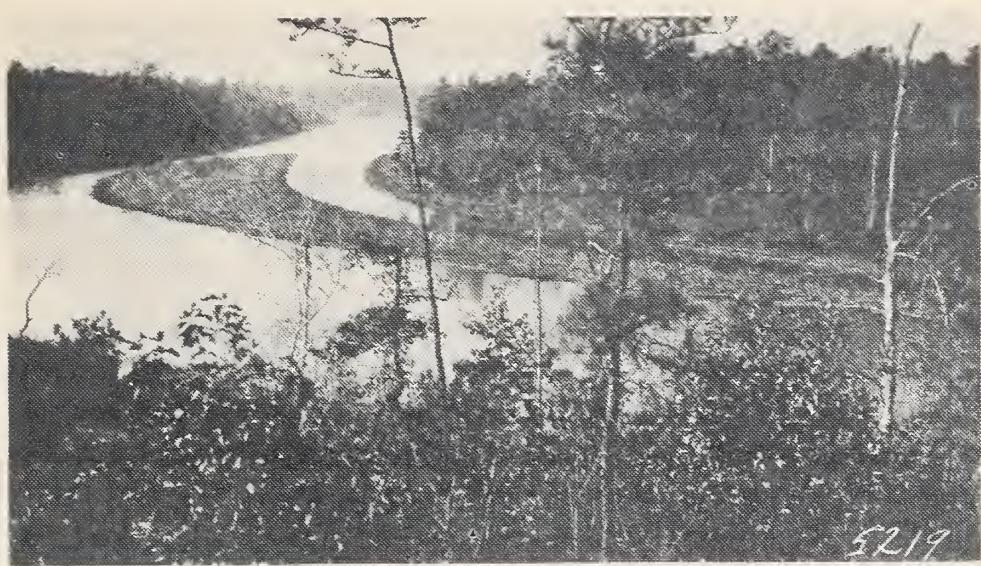
Two special features of sediment distribution are strikingly illustrated in Bayview Reservoir. The first consists of the occurrence of elongated crescentic bars of silt and sand, and depressions of similar outline, in the Village Creek arm above Camp Branch (fig. 5, in pocket). Both occur invariably at stream bends, the bars near the convex side of the channel and the depressions near the concave side either directly opposite or slightly downstream from the bars. In the narrower upper reaches of the Village Creek arm long narrow depressions occur without associated bars. All the bars, with the exception of the one at the first bend above Camp Branch, have been built slightly above spillway crest level. In most cases a shallow back-channel has been maintained between the bar and the main shore, so that the bars appear at crest stage as crescentic islands (fig. 6A). A single exception is the large bar opposite range end R-170, which is tied to the shore at its upstream end. These sand and silt bars are believed to have originated in the same manner as natural levees along a normal stream channel. They resemble levees in cross section, being highest near the channel and sloping gently toward the valley side.

A. Crescentic silt island in the Village Creek arm of Bayview Reservoir. Note the back-channel maintained by scouring action of flood waters on the inside of the bend.

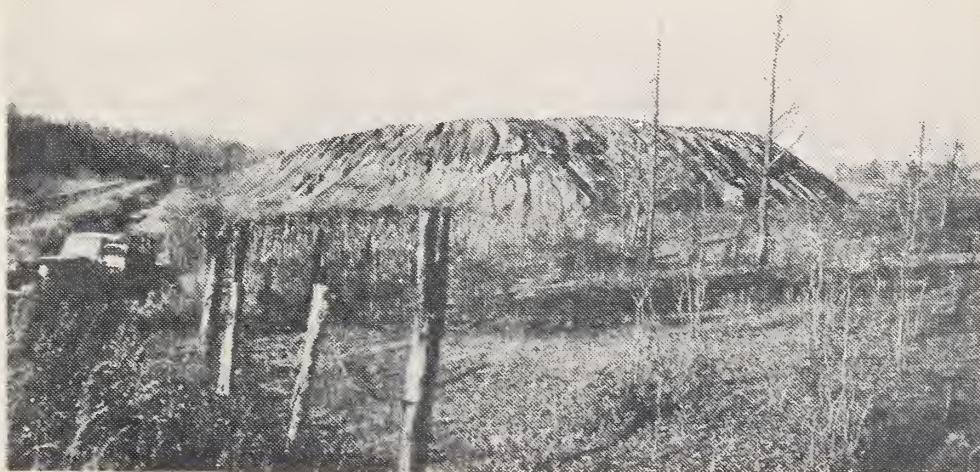
B. Refuse dump of the Docena coal mine, near the head of Bayview Reservoir. The Village Creek arm is just to the left of the area shown in the picture.

A considerable but indeterminate part of the storage capacity of the reservoir is thought to have been displaced by debris washed from the dumps of the several coal mines in the watershed. This material is in an ideal condition for rapid erosion, so that the run-off from each rain transports appreciable quantities to the drainage lines and thence into the reservoir. The extent to which these mine dumps are being eroded is indicated in figure 6B.
